ORIGINAL  
(Red)  
REPORT OF INSPECTION TO DETERMINE COMPLIANCE  
WITH THE TOXIC SUBSTANCES CONTROL ACT (TSCA) REGULATIONS

United Rigging and Hauling  
12120 Conway Road  
Beltsville, Maryland 20705

Inspection #85-017

Subject: PCB (TSCA) Inspection  
United Rigging and Hauling  
12120 Conway Road  
Beltsville, Maryland 20705

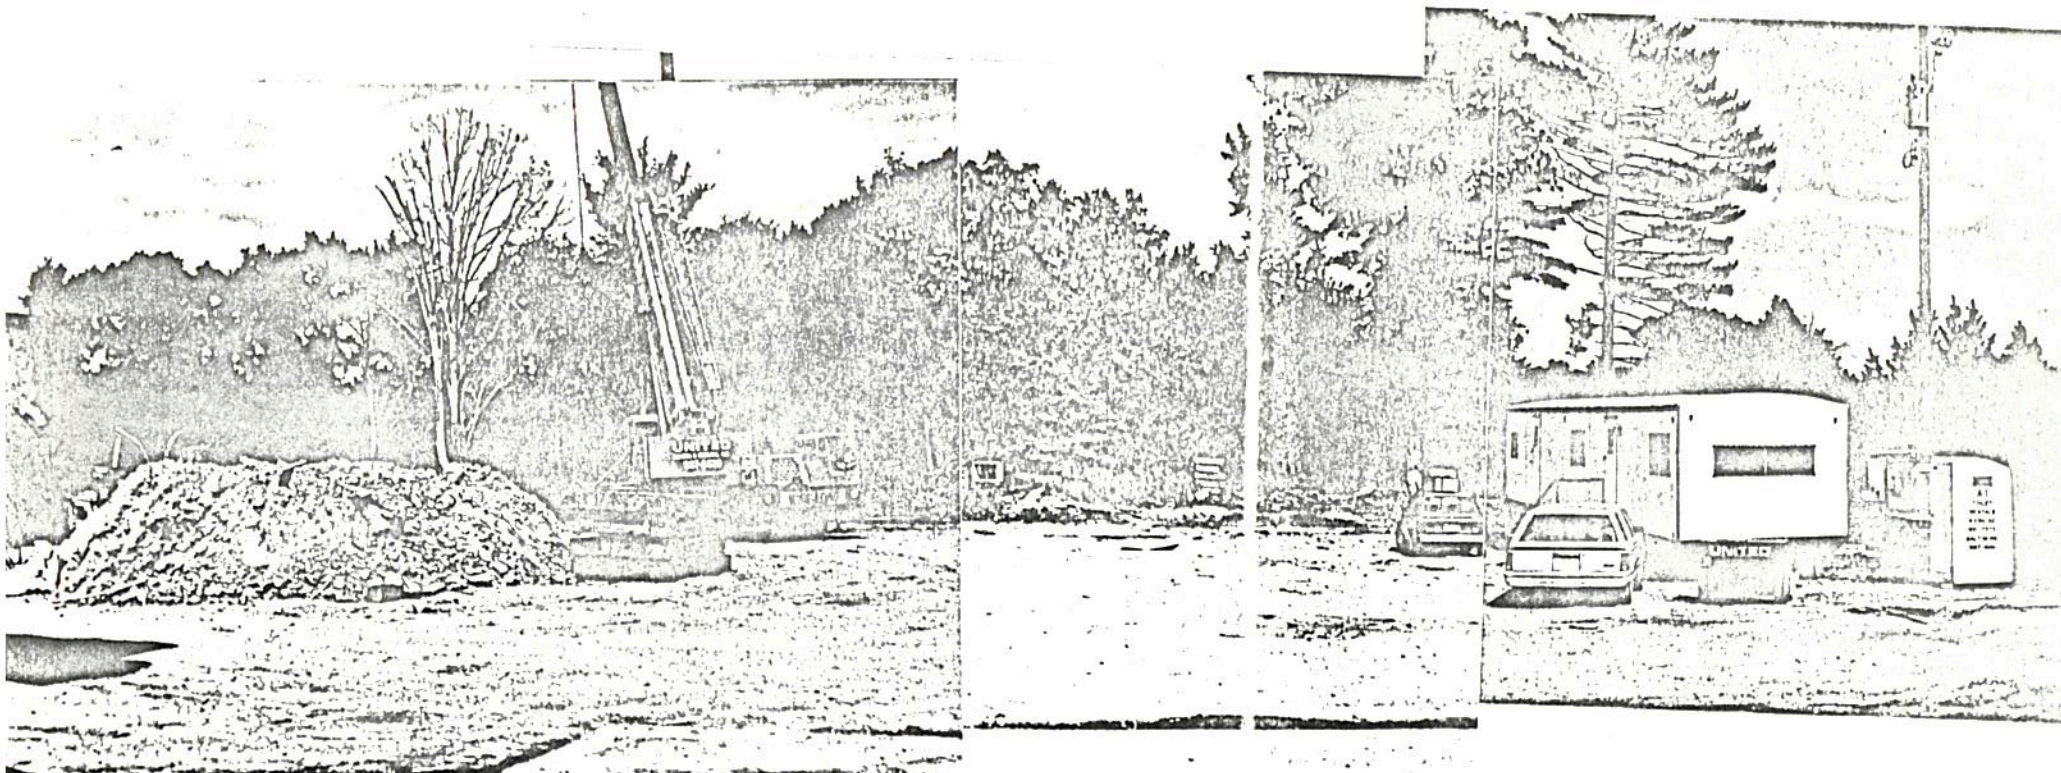
The major sources of interference are concentrated masses of iron and steel above the ground, powerlines and an operating transformer. An office trailer which serves as the PEPCO Command Post is located directly above the spot where Tom Bettendorf believes it is most likely the drums are buried.

Cleared area where drum burial is suspected. Note transformer and PEPCO command post in foreground.

The office trailer serving as the PEPCO Command Post sits directly above the suspected burial site and may have to be moved before further investigations.

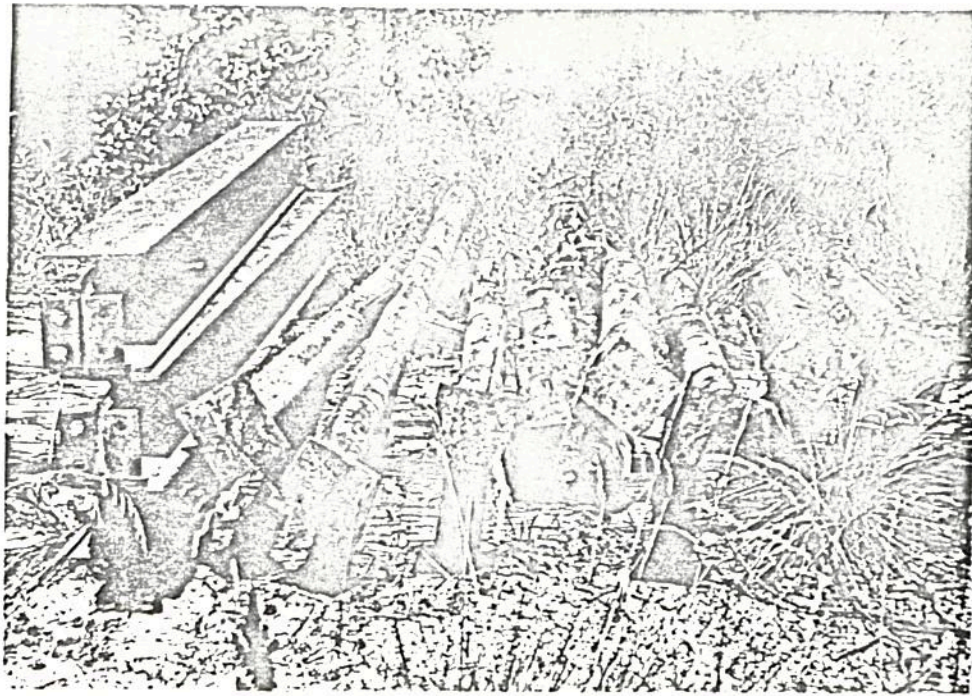
Concentrated masses of iron and steel on the site include stacks of "I beams", network transformers, junked trucks and flatbed trailers, and other scrapped items. Massive iron and steel items such as these can affect magnetic readings up to distances of 50 to 100 feet or more. Large masses of above ground iron and steel can "blot out" the ability to detect the much smaller amount of material suspected to be buried in the form of drums.

I-beams and columns which would cause interference with a magnetic survey.

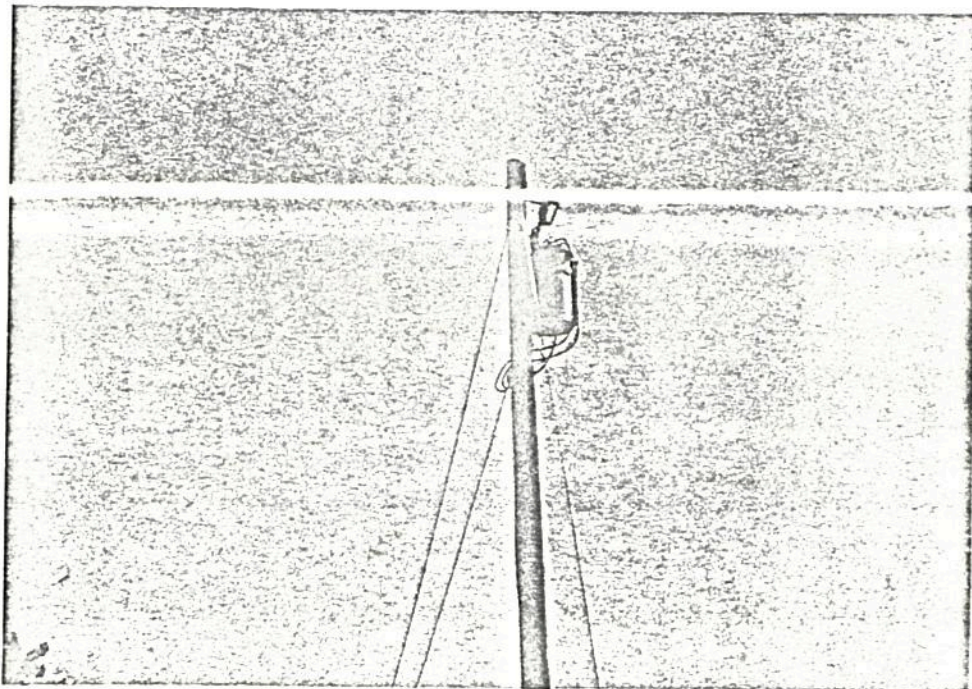
Powerlines and an operating transformer are also on the site. Sources of electricity have associated magnetic fields which produce erratic and unpredictable magnetometer readings to a considerable distance. Operating transformers are a particularly bothersome source of magnetic interference.

Operational transformer which would interfere with magnetometer readings.
